MK & Associates

Expert Report

17-095: NACSP Fall Protection System Certification of Testing

February 1, 2018

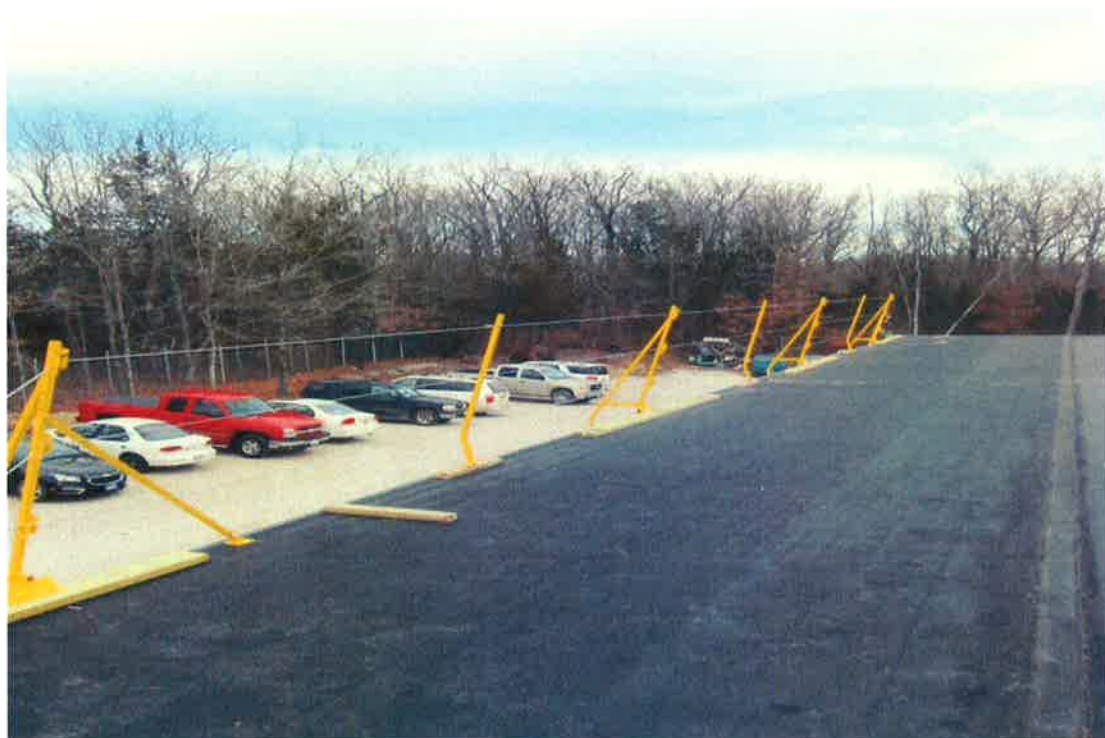
Figures 1 through 24 are photographs of the test set up; Figure 1 shows the complete 60 foot test section. On the left of Figure 1, one of the terminating stanchions is seen, then moving to the right in the photograph the next vertical element is a mid-rail. Further to the right, a standard stanchion is seen. The load during testing was applied in the middle of the section situated between the 1st mid-rail and the second stanchion, seen in Figure 1 of the test set up.

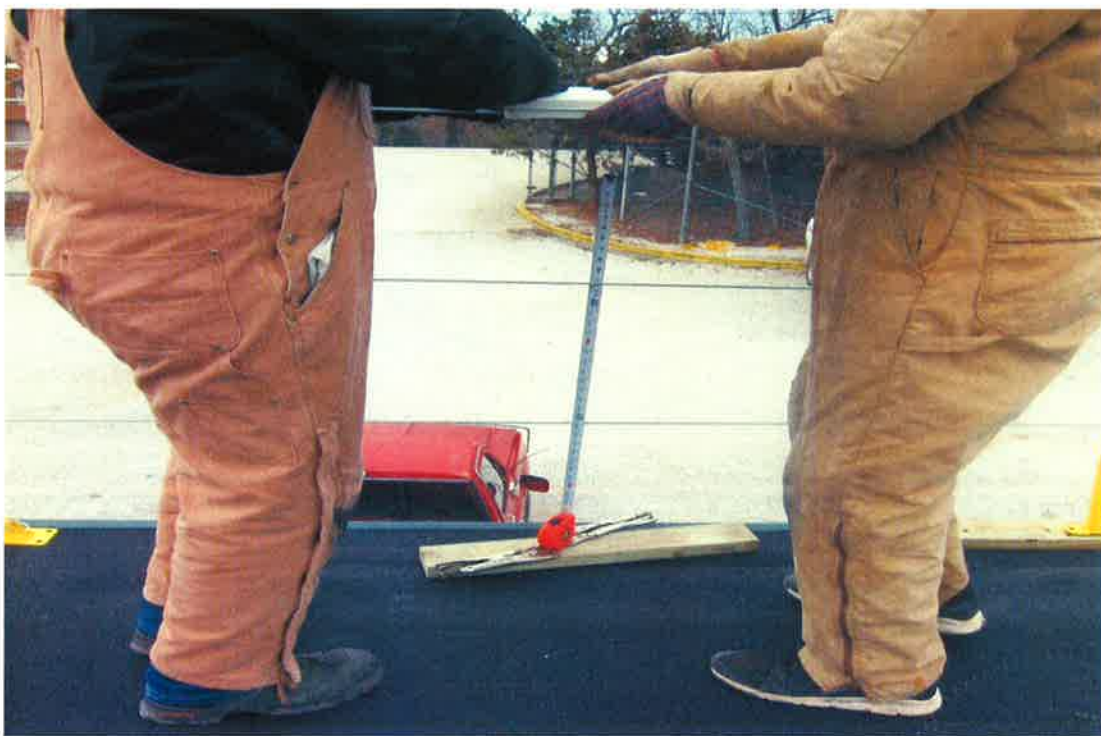
Figure 16 shows the 39 inch high role tape set up as a "go/no-go gauge" for the maximum deflection of the top cable run. Figure 16 further shows the positioning of the

mechanical load scale used to apply the test load and the manner that the test load will be applied. Figure 18 shows the upper end of the “go/no-go gauge” relative to the top cable run of the perimeter fall protection system prior to load being applied.
